# A Prairie Where Pollution Ruled

by Shane Sparks

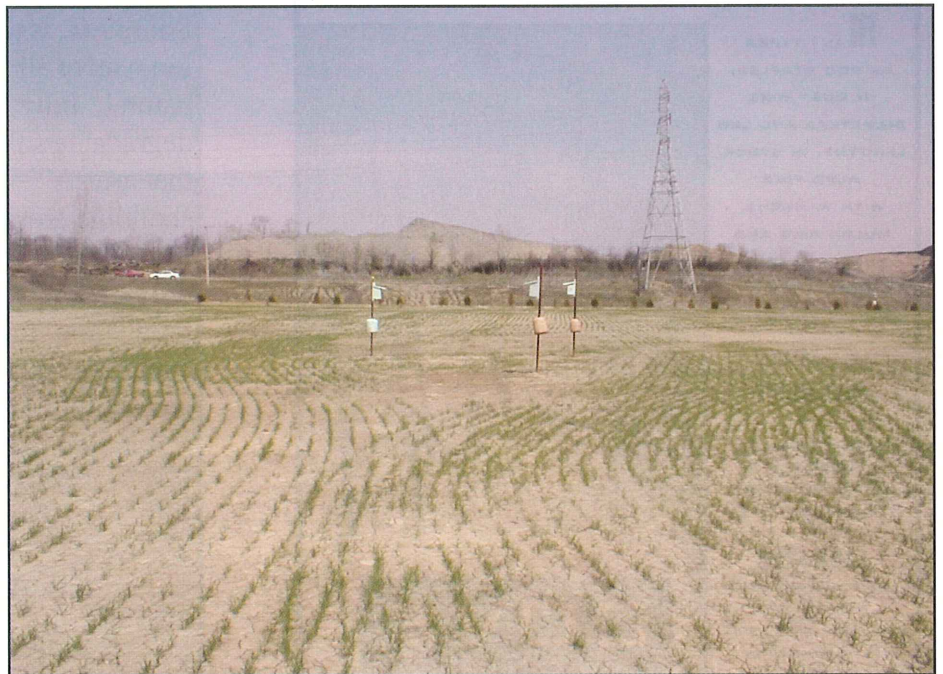
**E-Pond site pre-prairie establishment**

Site preparation is a critical step in any prairie restoration. Prairie species require good soil aeration and an adequate nutrient supply to properly germinate. In contrast to the initial prairie planting, E-Pond was adequately prepared before prairie planting. The upper two inches of soil was disked to enhance aeration and break up the soil, creating a uniform soil surface for the seed drill. Large soil clods present on the soil from the first planting were broken down by the disking to eliminate macropores that provide excessive aeration and can dry out germinating seeds.

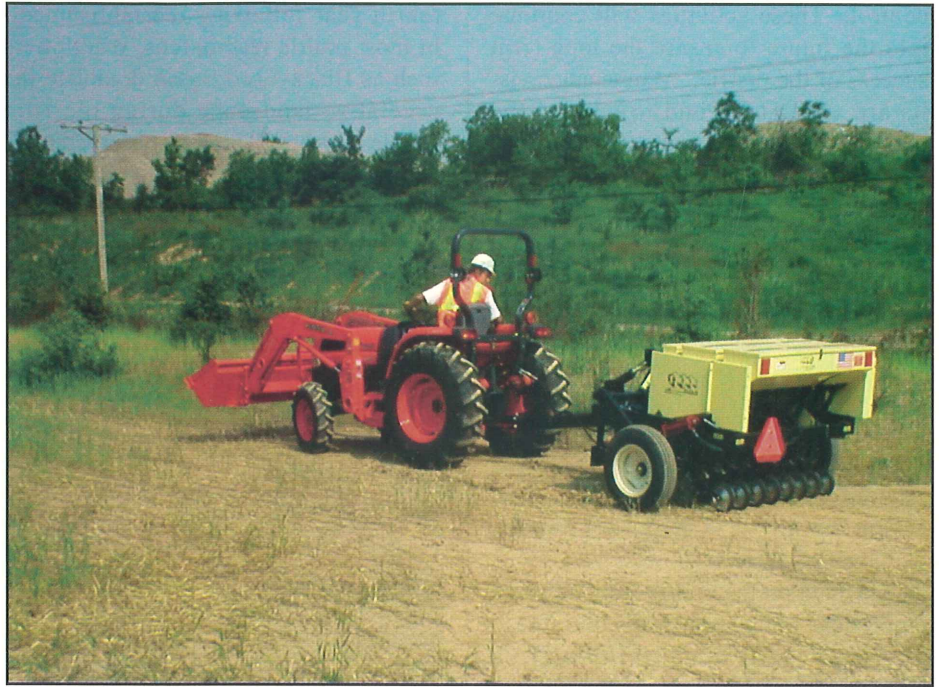
**Planting during prairie establishment.**

site with a Truax Seed Drill. The Truax Seed Drill was pulled behind a Kubota Tractor and works by creating small furrows in the soil before delivering a variety of seeds to the furrow. The final implement on the seed drill closes and lightly compacts the seed bed. The tall-grass prairie seed mix included such species as Big Bluestem (*Andropogon gerardii*), Black-Eyed Susan (*Rudbeckia hirta*), Sawtooth Sunflower (*Helianthus grosseserratus*) and Indian Grass (*Sorghastrum nutans*). The restoration planting also included grass and wildflower species that provide food and shelter to birds, insects, and mammals. Walking trails alongside the Ottawa River and E-Pond prairie have been established to provide educational tools on native Ohio habitats.

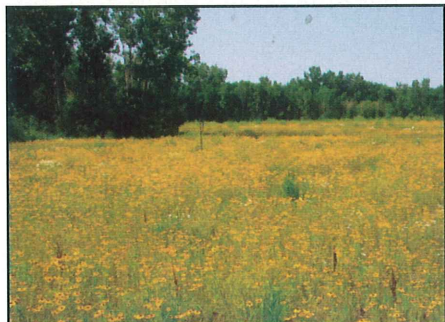
**Second year growth of Black Eyed Susan.**

fourth year following reestablishment. In most prairie restorations, wildflowers such as Black-Eyed Susan dominate the vegetative landscape during the first couple of years. This was observed at E-pond during the 2004 growing season. In subsequent years, the percentage of blooming wildflowers decreases slightly as prairie grasses such as Big Bluestem take over. This was observed during the

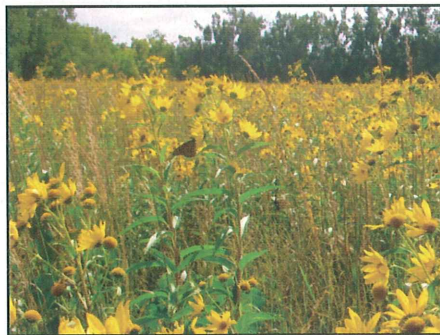
**Third year growth of Sawtooth Sunflower.**
